Manhole Inspection Summary

Manhole # S13EE2027MH

Insp Date: **10/16/06 10:12 AM**

Location Address: **2205 CROSS COUNTRY BLVD** Cross Street: **BONNIE VIEW DR**

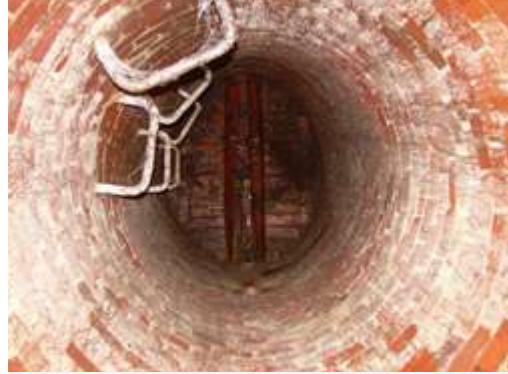
Top View

Bench debris.

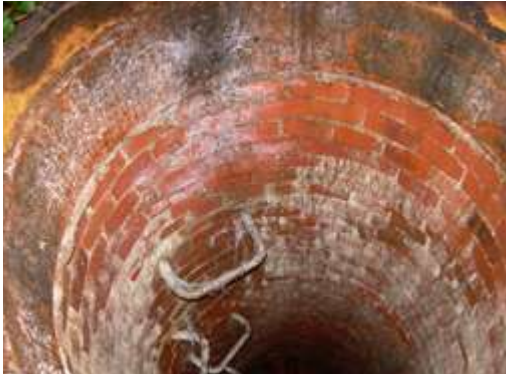
Defect

Frame leaks. Adjustment and Corbel infiltration.

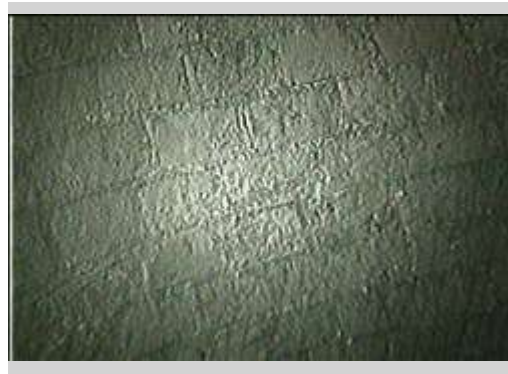
Defect

Corbel and Barrel infiltration.

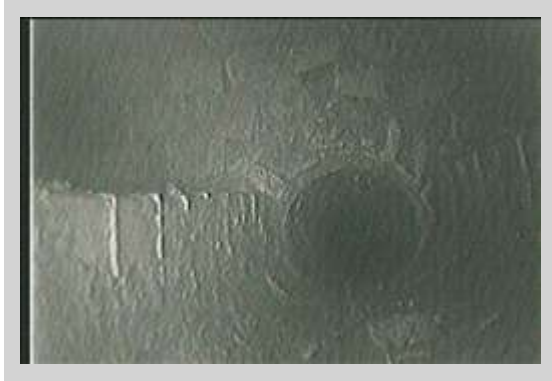
8 in. Circular Gravity Sewer Pipe Out @ 12 O'Clock

Infiltration: **Evidence** Pipe Seal Cond: **Unknown**

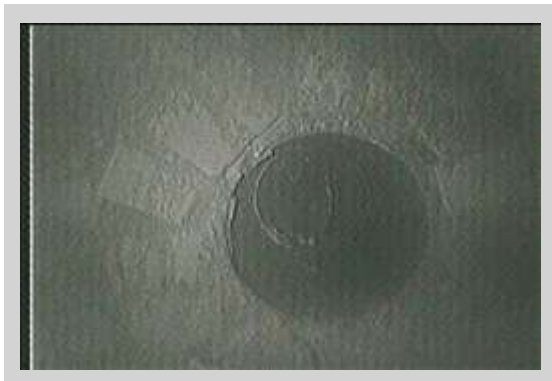
8 in. Circular Gravity Sewer Pipe In @ 6 O'Clock

Deposits: ☐ None ☐ Mud ☐ Sludge ☒ **Debris** ☐ Grease

Silt Depth: **7** (in.) Deposits Extent: **Heavy**

Infiltration: **Evidence** Pipe Seal Cond: **Unknown**
